## PRELIMINARY STRUCTURAL ENGINEERING INSPECTION REPORT ON APARTMENT COMPLEX AT 34 PINEHILL COURT, FRANKSTON FOR BUILDING COMMISSION

I report on a preliminary inspection of a 12 unit apartment complex at 34 Pinehill court, Frankston on Thursday 19<sup>th</sup> August 2010. The purpose of the inspection is to determine the structural integrity of the building in relation to an emergency order placed on it.

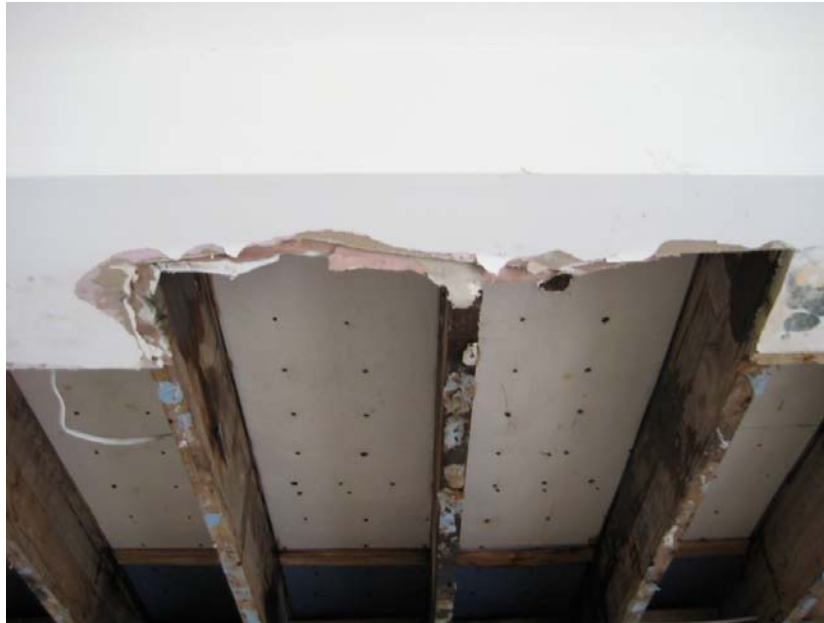
A number of the balconies on the third level are leaking. I inspected the units 4 and 1. The balcony above unit 4 leaks to the extent that the plaster ceiling has fallen away and the carpet below is water damaged. The chipboard flooring has rotted away to the extent that I do not consider it safe to access the balcony. The timber floor joists are water stained, but they do not appear to be damaged to the extent that the structural integrity of the timber is compromised. The plaster ceiling in the kitchen of unit 1 is extensively water damaged although the plaster has not fallen away yet. There is a timber framed balcony over the kitchen.

Water damaged flooring above ceiling

It is my recommendation that the balconies that are leaking not be allowed to be accessed as I cannot be certain the structural integrity of the chipboard is adequate to support the designed live load.

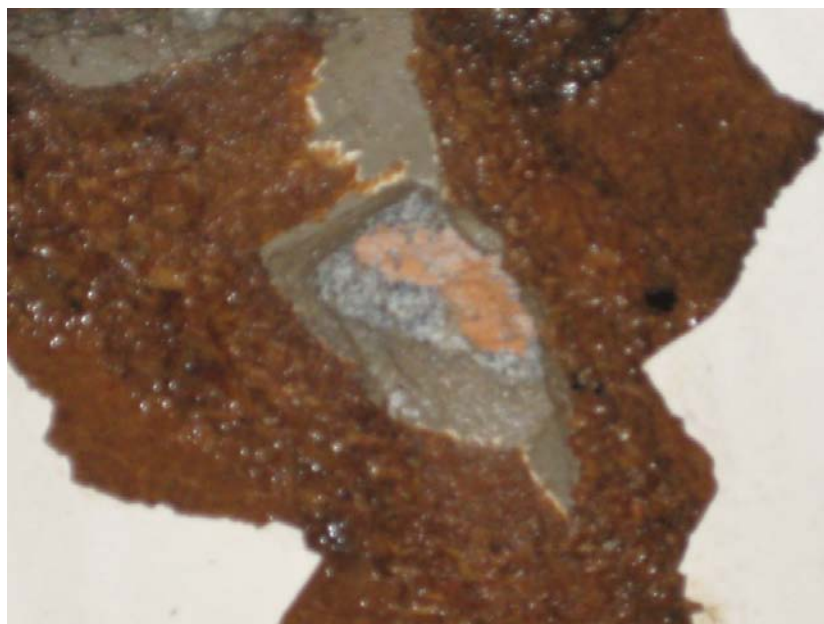
Rotted chipboard flooring

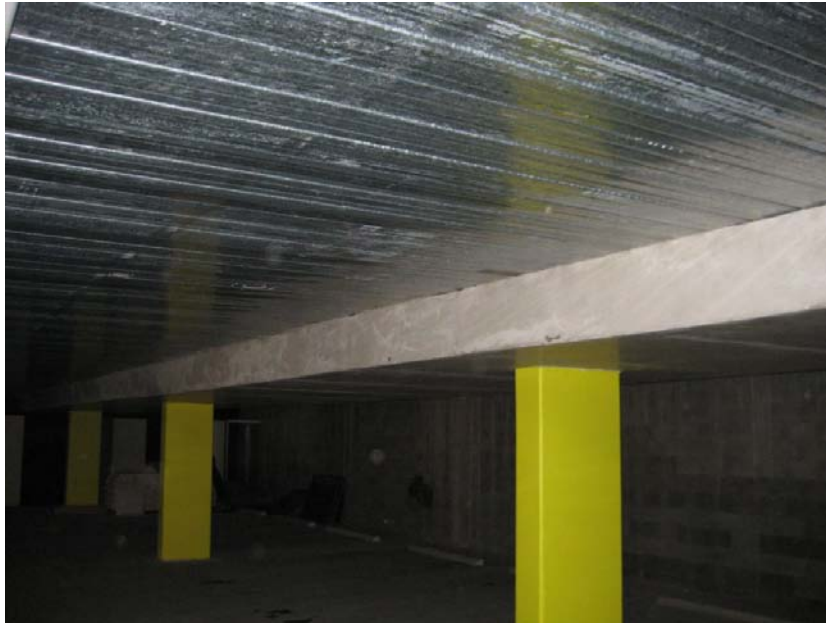
A number of structural Engineering drawings of were provided for my perusal at the inspection. The approved first floor level plan shows a reinforced concrete floor slab supported on a system of structural steel beams. The first floor actually consists of reinforced floor slabs supported on reinforced concrete band beams and reinforced concrete columns. The construction does not accord with the drawings.

Although the concrete floor does not comply with the approved drawings supplied to me the structure does not appear to be inadequate such that failure is imminent. Further investigation is recommended however to fully determine the suitability of the slab.

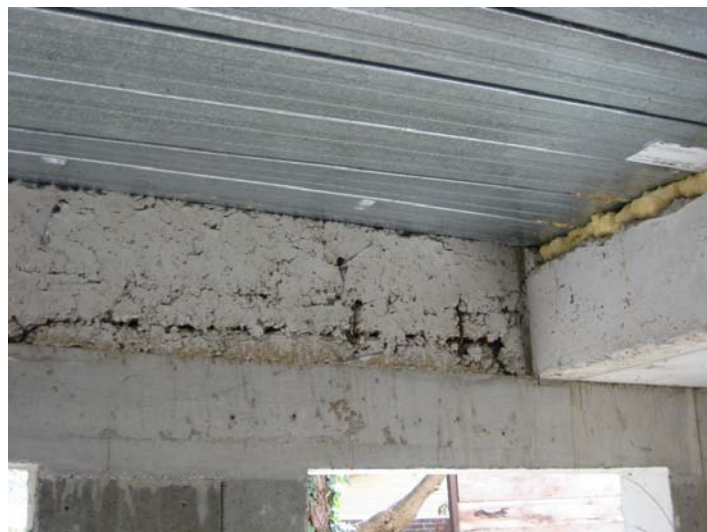
At the inspection there was no evidence that there is any impending failure of the floor structure. There does not appear to be any shear or bending failure in the slabs or band beams. At one of the outer edge beams the reinforcement is exposed to the extent that the concrete has not been properly compacted and there is no cover. This beam does not appear to be critical in the support system however.

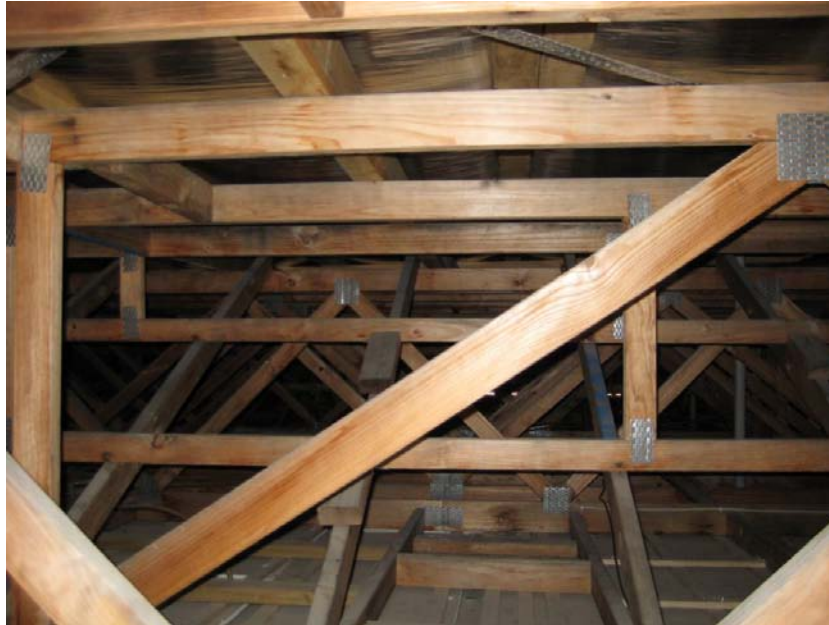
The roof is supported on a system of prefabricated trusses. An extensive examination of the sizes, spacing etc. was not carried out. An inspection of the structure in general indicates there is no excessive deflection or bending distress.

Roof truss system

The structural integrity of the roof support system appears satisfactory at this time. However further investigation is recommended considering the non compliance in other areas.
